Forest  
Products  
Laboratory

Research  
Paper  
FPL 342  
1979

# Structural Sandwich Performance After 31 Years of Service

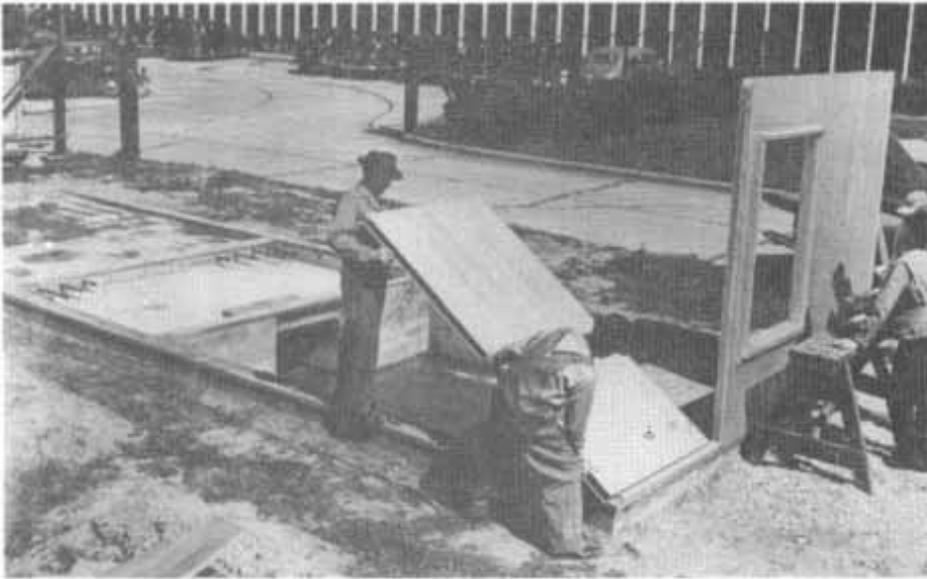
Figure 1.—Construction of the original experimental unit in 1947 in front of the main building of the Forest Products Laboratory. Note both the crawl space for the east room in which the floor panels were installed, and the concrete subfloor for the remainder of the unit. (M 73607 F)

Construction of the original experimental unit was carried out in June 1947 (fig. 1). The overall dimensions were 38 feet 6 inches by 12 feet 6 inches.

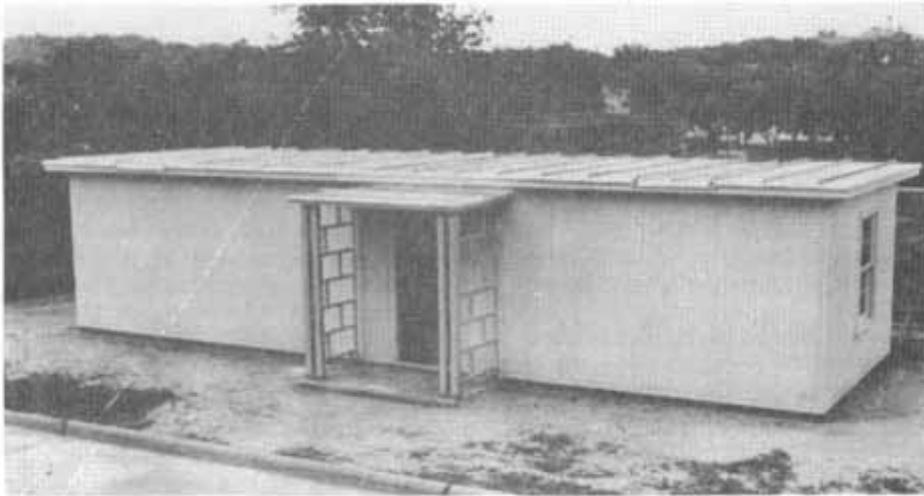
Figure 2.—Original Forest Products Laboratory experimental unit (M 73988 F) or = (FM 116 396)

**Walls.** —The completed experimental unit, shown in figure 2, was oriented so that long sides fronted north and south for minimum and maximum exposure respectively to the sun. Ten panels were placed in each of the two elevations, as shown in figure 3, generally in matched pairs so the effect of differing degrees of exposure to the sun could be studied. The panels rested directly on the sill, fitting over a sole plate secured to the sill. Panels were 8 feet high and either 3 feet 11½ inches or 2 feet 11-inches wide. A ½-inch space was provided between panels allowing independent movement of each panel that could be measured in response to seasonal weather changes. The space was filled with a felt gasket and sealed with tape. A ¾-inch by 2½-inch continuous plate, placed in a groove along the top of the panels, tied the panels together. Cleats glued to the roof panels were seated in the same groove above the continuous plate and the panel facings were fastened to the cleats with screws.

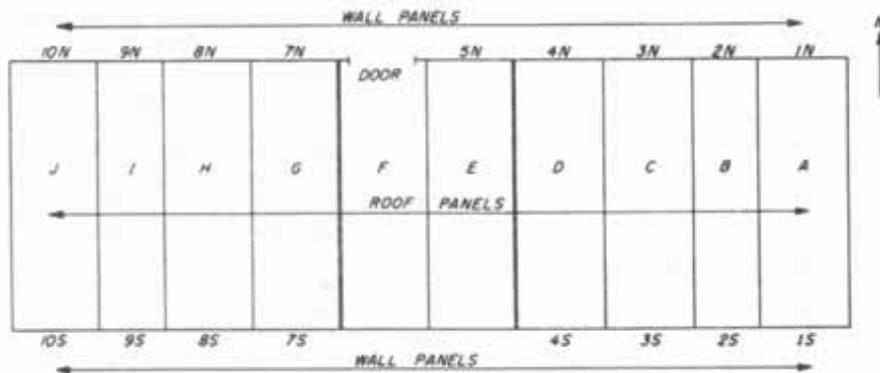
Figure 3.—Positions of original numbered wall and roof panels in sandwich experimental unit. (M 126 174)

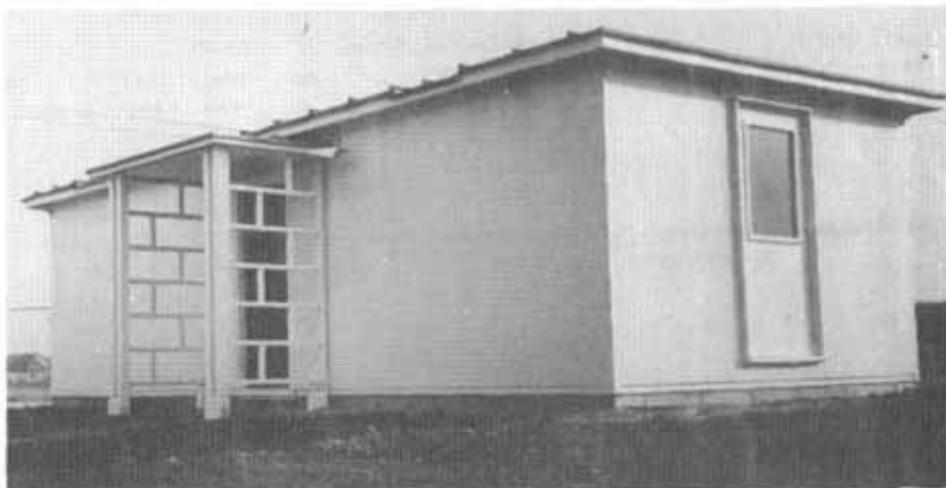
Figure 4.—Sandwich experimental unit as re-erected in 1968. (M 135 634-3)

experimental unit and reconstruct it at a new site in 1968 (fig. 4). The dimension of the long side **was** modified to 32 feet 6 inches, which accommodated nine panels instead of the previous ten (fig. 5). Three sandwich floor panels, instead of four, were placed in the west room. The radiant heating system was replaced by electric space heaters in the relocated unit, although the copper tubing in the floor panels remained intact.

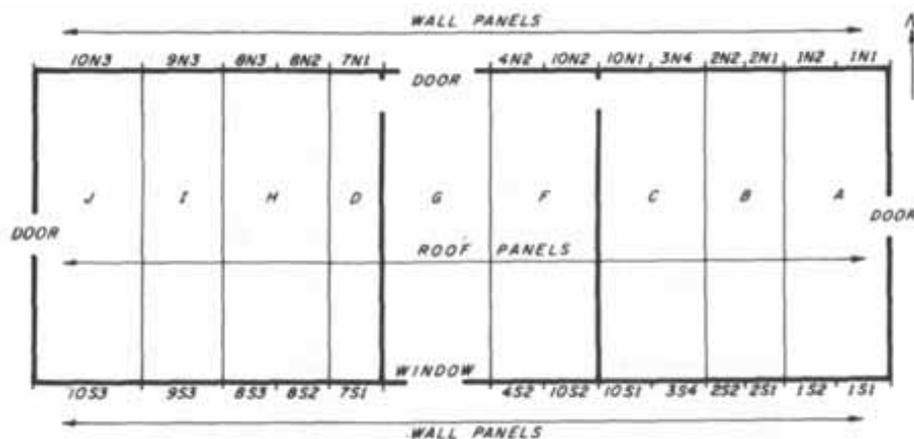
Figure 5.—Positions of numbered **wall** and roof panels in the sandwich experimental unit (1968). (M 138 281)

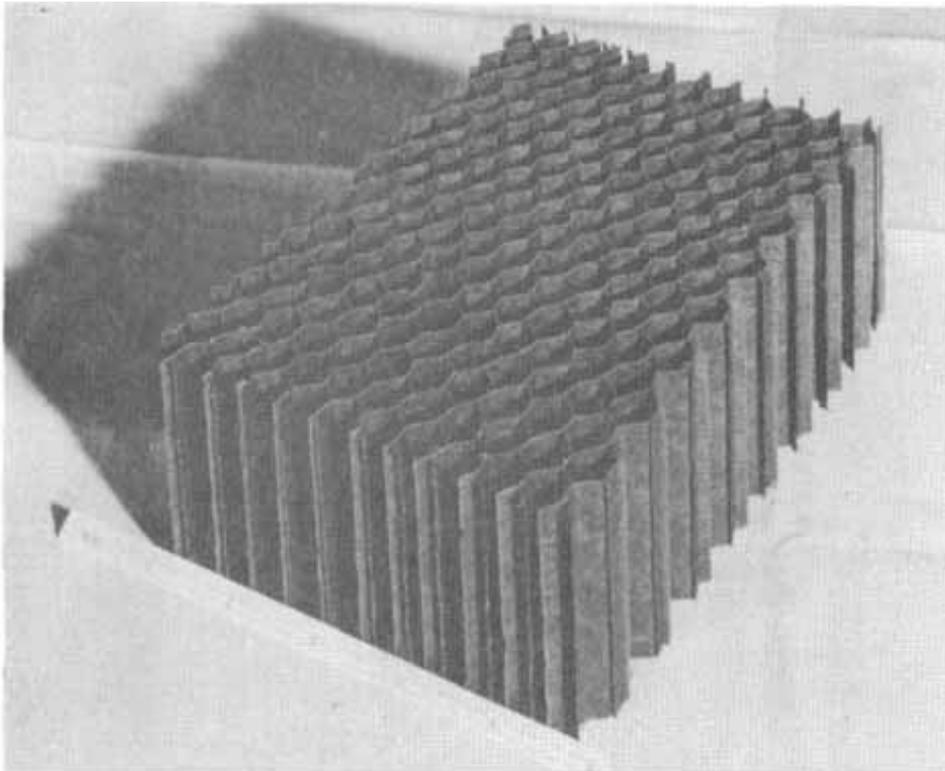
Figure 6.—Expanded hexagonal paper-honeycomb sandwich core. (M 87220 F)

An expanded type core (Fig. 6) was produced from sheets of paper bonded flatwise at intermittent lengths and then pulled—or expanded—to develop a hexagonal pattern. Only the commercially manufactured panels had expanded cores.

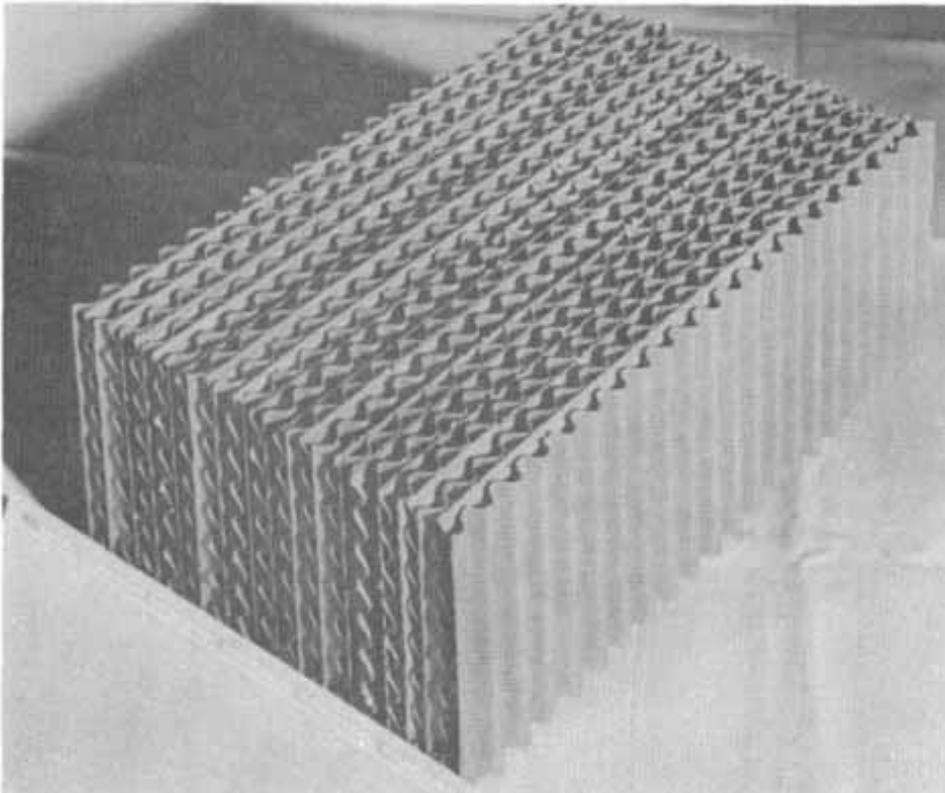
Figure 7.—XN type of corrugated-paper honeycomb core. (M 87222 F)

The core designated XN (fig. 7) was made up of corrugated sheets glued together with corrugations of adjacent sheets at right angles. The assembly was cut in the required thickness and arranged so that alternate corrugated sheets were positioned with flutes parallel and perpendicular to the facing.

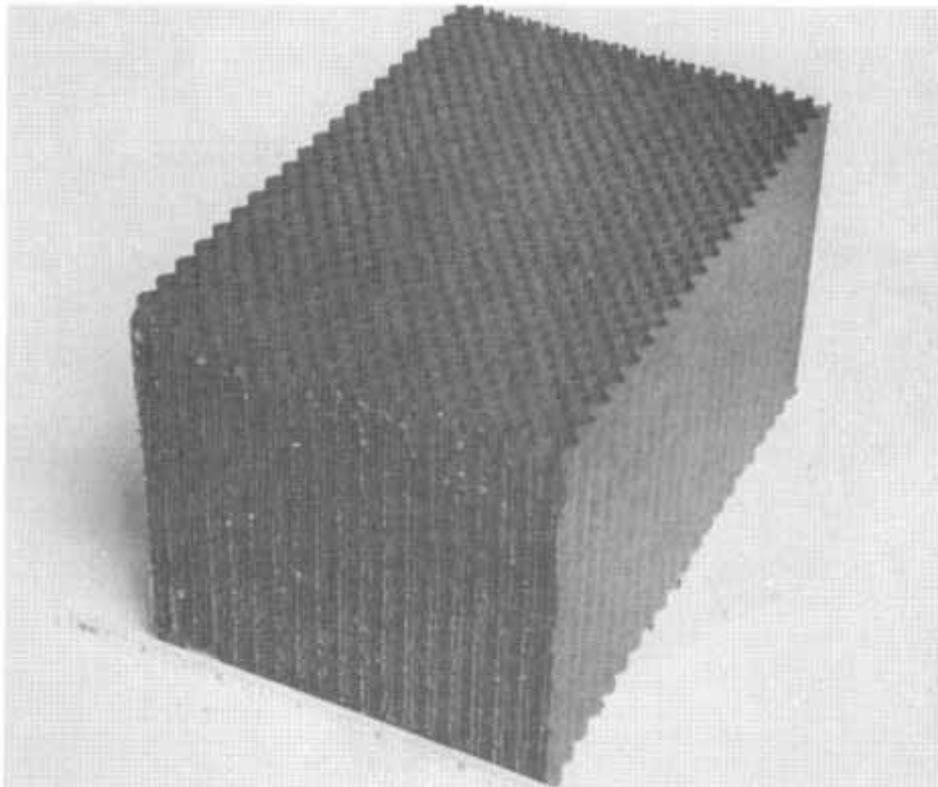
Figure 8.—PN type of corrugated-paper honeycomb core. (M 88875 F)

The core designated RN (fig. 8) was assembled with all flutes parallel. Panels

were assembled with flutes perpendicular to the facings.

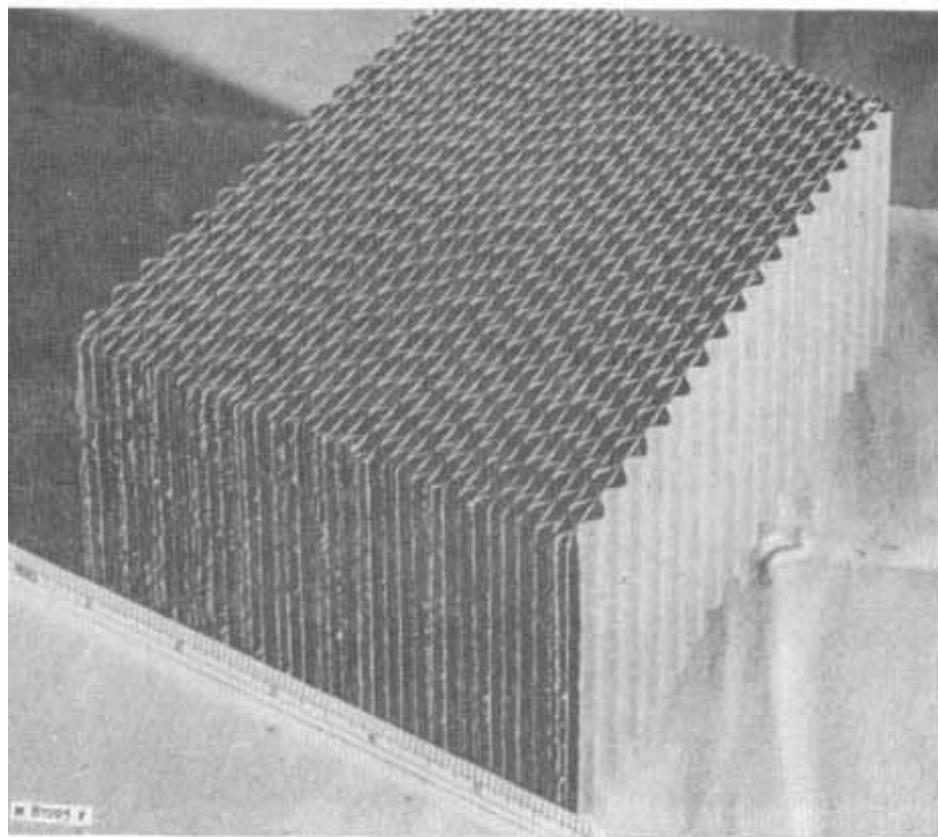
Figure 9.—PNL type of corrugated-paper honeycomb core with flat interleaves between the corrugated sheets. (M 87223 F)

One of the two pairs of commercially manufactured panels with aluminum facings (9N1, 9S1) was replaced with two panels (9N2, 9S2) of unbalanced construction, having ⅛-inch high-density hardboard on one face and porcelainized steel OR the other. The core material was a type PNL paper honeycomb, a variation on the type PN core with layers of single-faced corrugated board (corrugated paper faced on one side with a flat sheet of paper, **assembled** as shown in fig. 9).

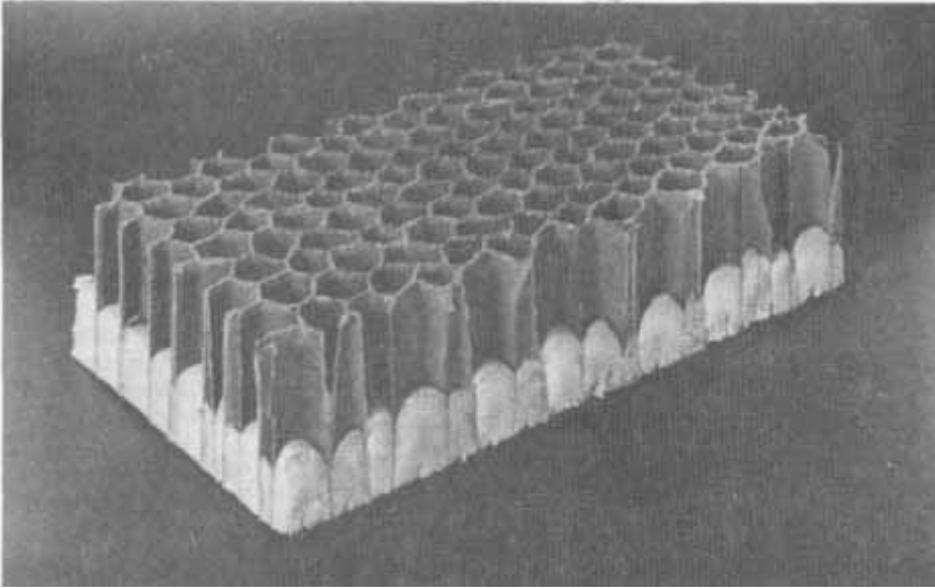
Figure 10.—Expanded hexagonal paper-honeycomb core with 1-inch polyurethane foam from one side. (M 135 580)

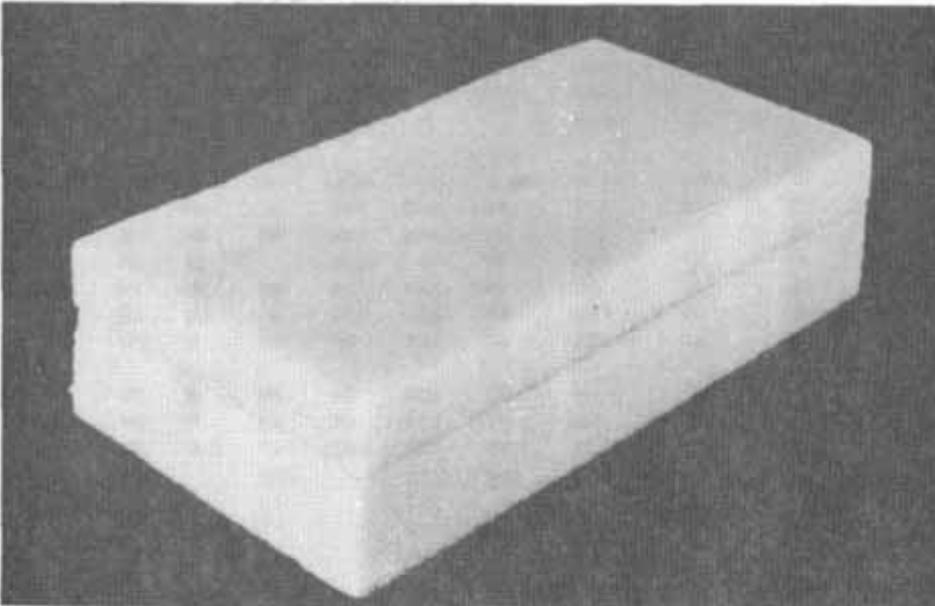
Figure 11.—Extruded polystyrene core with density of 1.9 pounds per cubic foot. (M 135 581)

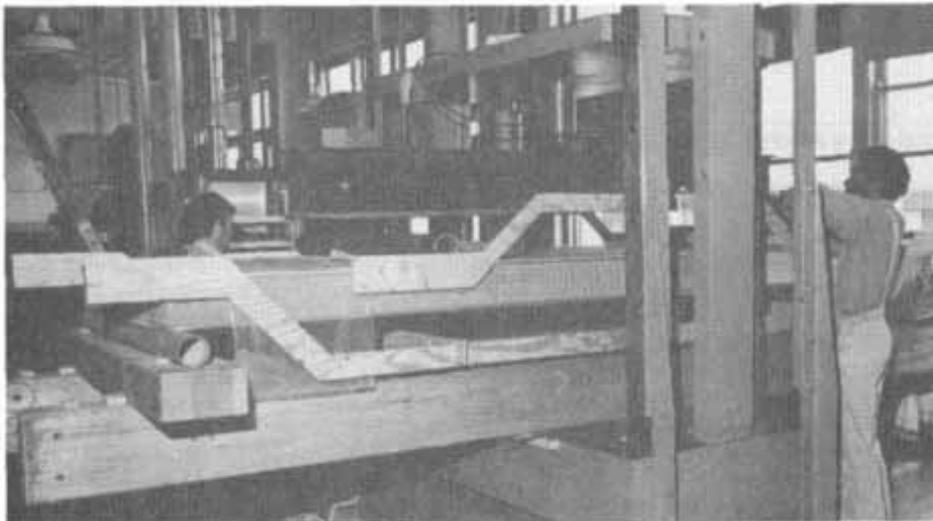
Figure 12.—Typical setup for a panel to be tested for bending strength and stiffness in 1978. (M 147 139-2)

Tests were conducted in accordance with ASTM Standard E72-74a(1).<sup>2</sup> A typical test setup is shown in figure 12.

Quarter point loading was used to provide the same maximum shear and moment as an equivalent uniform load. Plywood yokes with attached dial micrometers were used along both sides of the panel to record deflection at midspan until the design load was reached. Design loads were 20 pounds per square foot for wall panels, 25 pounds per square foot for roof panels, and 40 pounds per square foot for floor panels. In 1978, the manual micrometers were replaced with electronic transducers, and load and deflection data were recorded automatically on an x-y plotter. Rate of loading was estimated according to a procedure in (5) to give a time of test between 6 and 20 minutes. Also in 1978, an additional pair of yokes with transducers was employed, as shown in figure 13, to measure deflection in the short span between the two quarter-point loads which is free of any effect from shear forces.

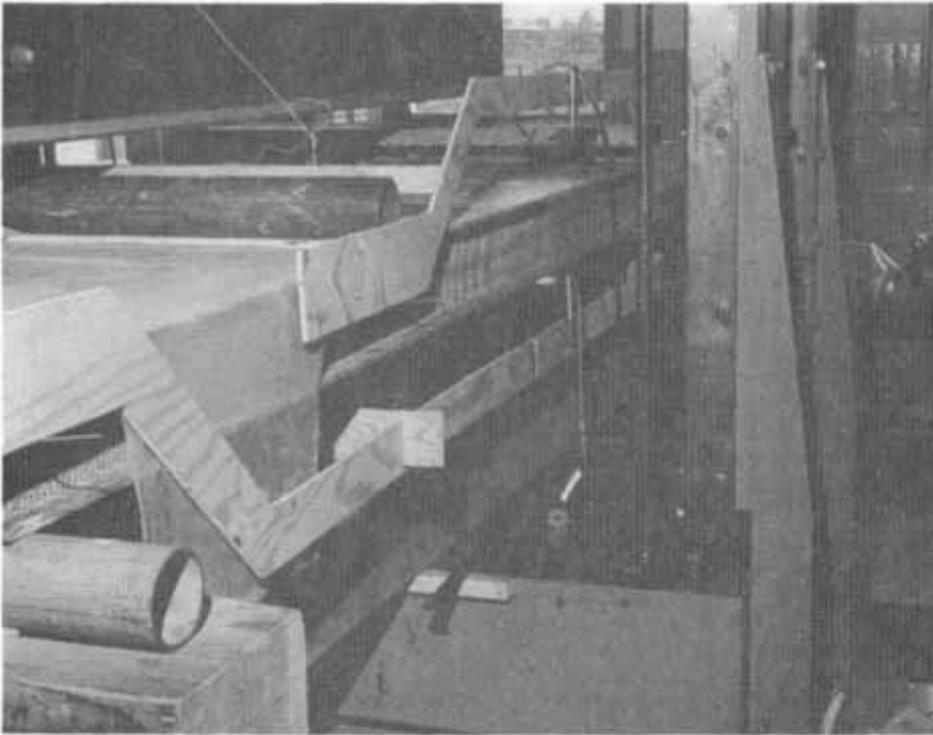
Figure 13.—View of panel ready for testing, showing both the long and short yokes with transducers for measuring midspan deflection. (M 147 139-1)

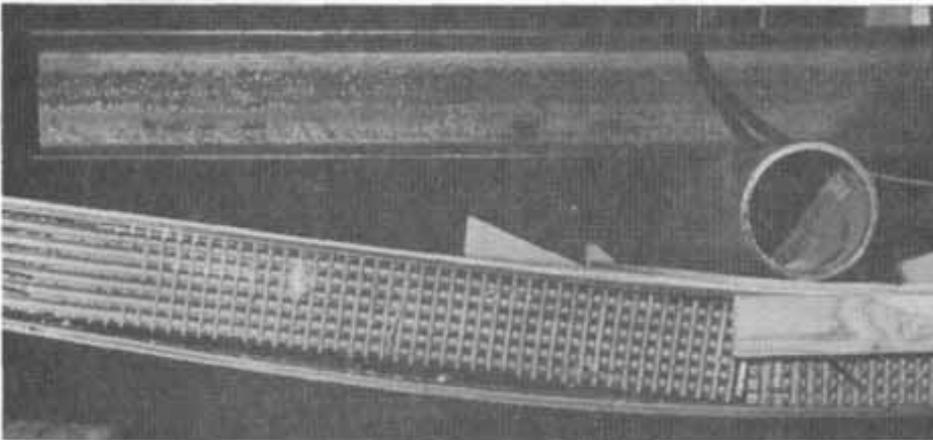
Figure 14.—View of shear failure in the paper honeycomb core material along the glue line in a panel faced with plywood (panel No. 1N1). (M 147 103-7)

sandwich panels failed as a result of shearing in the core material. Particularly in plywood-faced panels with corrugated paper honeycomb core, shearing would occur in the core material alongside the glue line (fig. 14). Only in one pair of plywood panels (7N1, 7S1) was there evidence of failure in the glue bond itself (fig. 15).

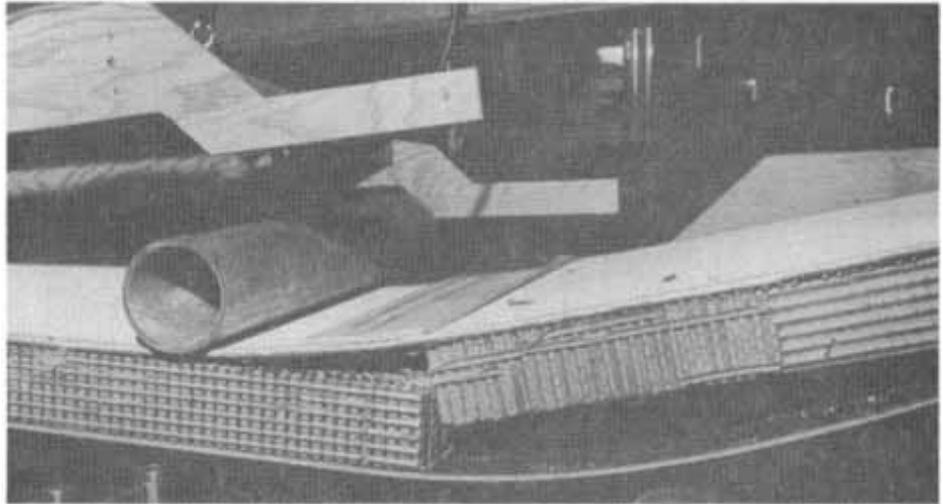
Figure 15.—View of shear failure in a panel with corrugated paper core and plywood lacing. Some failure in glue bond was evident. Note that the shearing surface changes from lower inside facing to top at the point of interface between two sections of core material (panel No. TN1). (M 147 104-1)

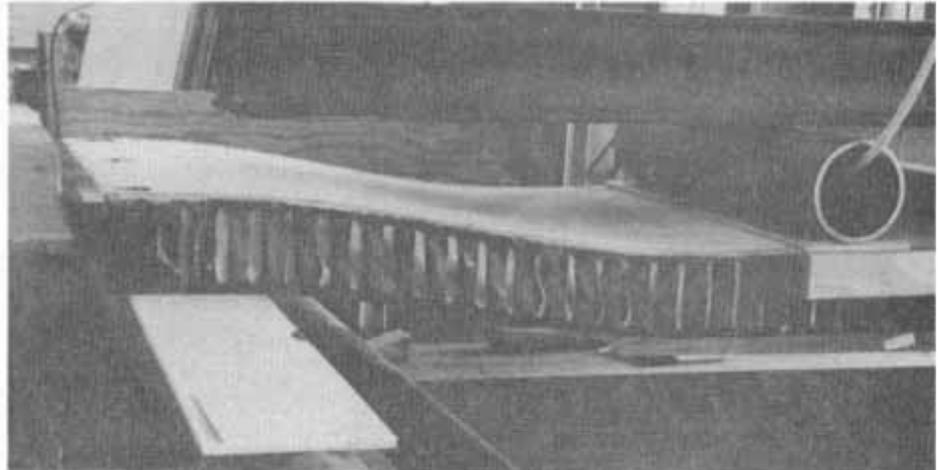
Figure 16.—View of failure due to shear in a panel with fiberboard facings and expanded type of core (Panel No. 3S4). (M 147 139-11)

In the fiberboard-faced panels (3N4, 3S4), a layer of fiberboard had pulled away, with the bond between glue and fiberboard completely intact. Failure in these two panels was accompanied by wrinkling of the core material (fig. 16), which was frequently the case with the expanded type of paper core.

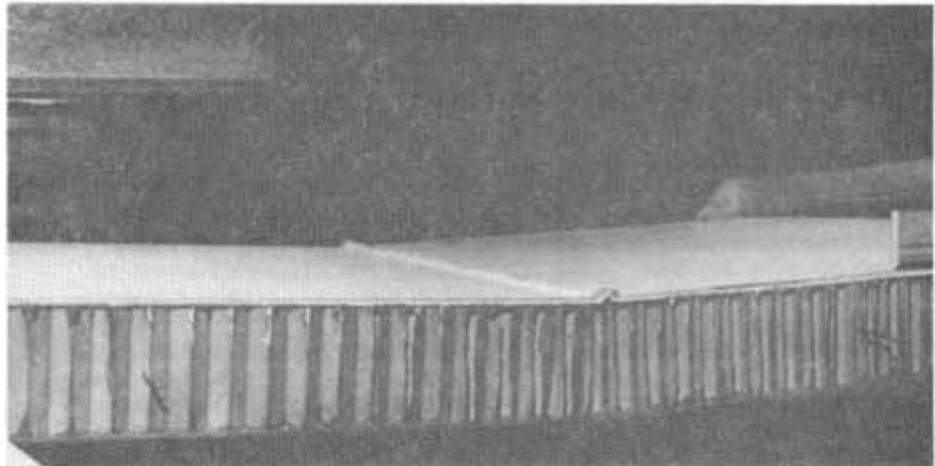
Figure 17.—View of failure in paperboard facing due to local buckling on compression side (Panel No. 1N2). (M 147 103-1)

Aluminum-faced panels failed in local buckling in the top compression facing by suddenly bulging out from the core. Close observation revealed that when the facing had separated from the core, the adhesive had not adhered to the aluminum surface. Paperboard-faced panels also failed in compression of the top facing that resulted in local buckling (fig. 17).

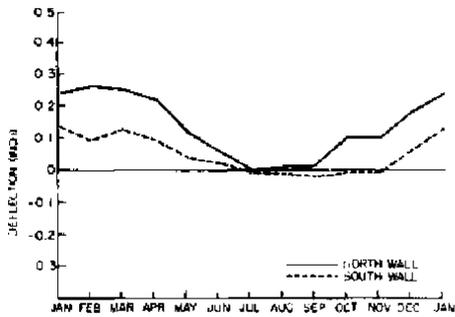
Figure 18.—Seasonal bowing of plywood-faced panels with paper cores (15-year average).

Among panels faced with wood-based products, plywood panels with paper cores bowed the least with a maximum outward bow of about  $\frac{1}{4}$  inch during the winter months. However, plywood-faced panels with polyurethane and polystyrene cores bowed much more, perhaps due to a greater moisture content differential between inside and outside facings. The average bowing throughout the year is minimal in aluminum-faced panels.

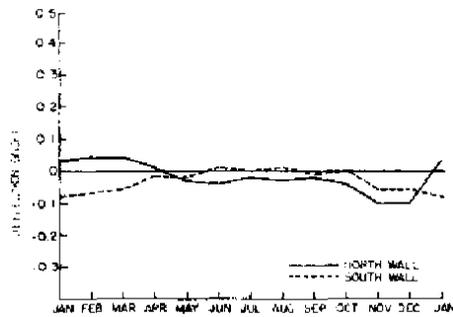
Figure 21.—Seasonal bowing of aluminum-faced panels (15-year average).

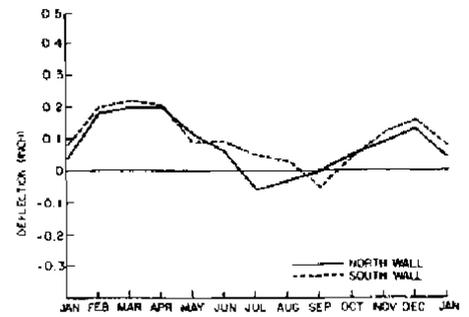
Figure 24.—Seasonal bowing of paperboard-faced panels (4-year average).

**Paperboard-faced panels (4 inches thick).**—Bow of north and south panels was almost identical with maximum outward bow during the winter months

of 2/10 inch and with a slight inward bow in late **summer** (fig. 24).

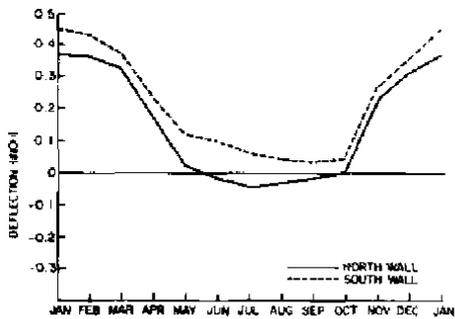
Figure 19.—Seasonal bowing of plywood-faced panels with urethane cores (9N3 9S3) (3-year average).

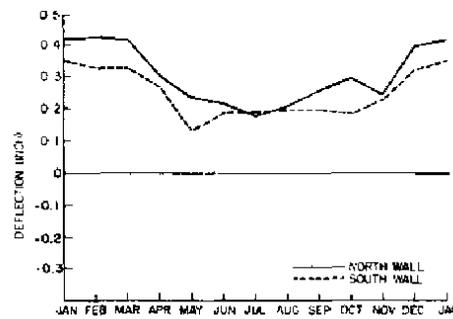
Figure 22.—Seasonal bowing of particleboard-faced panels (2N2, 2S2) (4-year average).

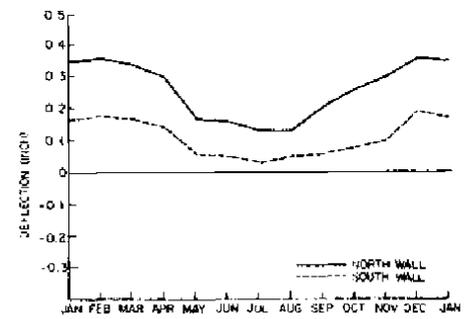
Figure 25.—Seasonal bowing of medium-density hardboard-faced panels (4-year average).

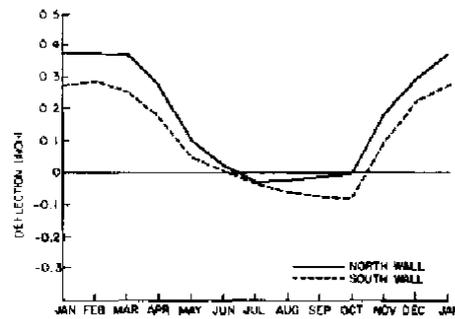
Figure 20.—Seasonal bowing of plywood-faced panels with styrofoam cores (10N3, 10S3) (3-year average).

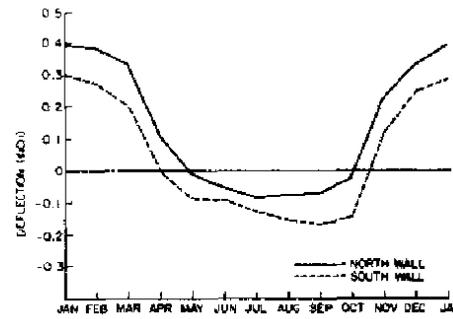
Figure 23.—Seasonal bowing of particleboard-faced panels (8N3, 8S3) (3-year average).

**Particleboard-faced panels (8N3, 8S3).**—North and south panels bowed in similar patterns, the north panel reaching a maximum at 4/10 inch and the south panel at 3/10 inch in January (fig. 23). Both panels bowed inward slightly during the warmer half of the year.

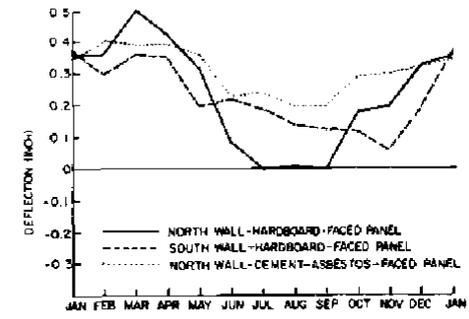
Figure 26.—Seasonal bowing of high-density hardboard- and cement-asbestos-faced panels (15-year average).

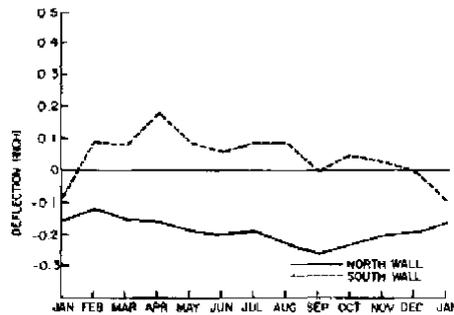
Figure 27.—Seasonal bowing of panels with plywood outside, aluminum-faced hardboard inside (4-year average).

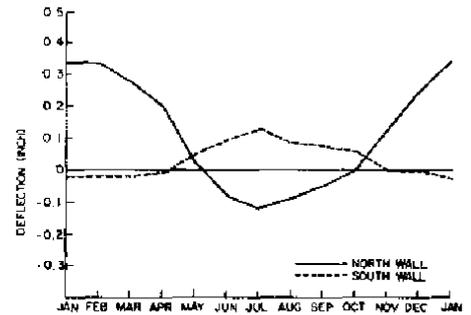
Figure 28.—Seasonal bowing of roof panels (15-year average).
